ST ODULPH'S CHURCH PILLATON, CORNWALL

St Odulph, Pillaton Lightning Repair Works

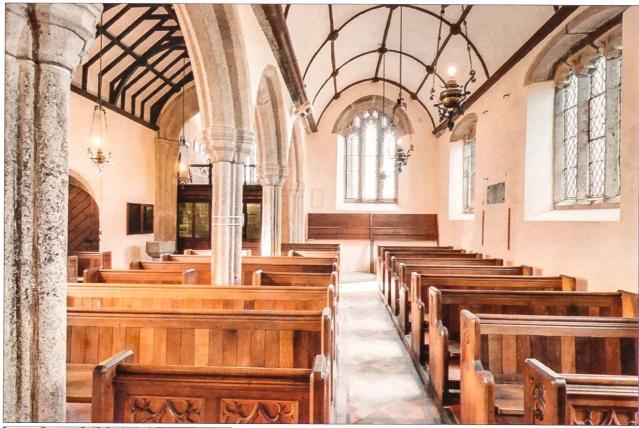
After the devastation which met the villagers in January, it was discovered that the lightning

blast had caused huge blocks of stone to crash through the church roof and other masonry fragments to be scattered throughout the churchyard and surrounding fields. Amanda Le Page stated that "it has been really satisfying that the repair and restoration of the church has been achieved in such a short time. The church looks complete once more after the north-east pinnacle was pieced together like a giant jigsaw, re-using as much recovered original stonework as possible."

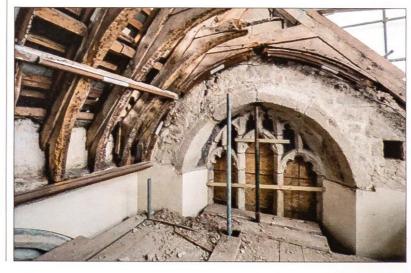
After devastating lightning strike damage to St Odulph's Church in Pillaton, Cornwall. in January 2013 Le Page Architects were commissioned to undertake a systematic stabilisation and restoration of the historic medieval Grade I listed building. Simon Crosbie led a team of engineers, stonemasons and contractors on a ninemonth project to repair and reconstruct the internal and external fabric of the building. The extensive nine-month restoration project encompassed work on the stonework, roof trusses, leadwork, window heads, plasterwork and interior fabric of the church, all of which had been severely damaged by the debris. The north-east tower pinnacle was completely destroyed. The pinnacle stone pieces were painstakingly gathered and reassembled in the stonemason's yard as a 3D jigsaw, in order to enable a dry-built assessment of the required restoration and remedial works.

Onceonsite the stone masons sympathetically replaced missing or stones too damaged to reuse with Cornish granite all lifted up to the tower via a specialist scaffolding and hoist which ensured the church was weather protected for the duration of the contract.

Careful intervention and connection of the new and mediaeval timbers were detailed so as to retain the mediaeval structure wherever possible.

The lead roof was severely damaged by the falling granite and so whilst retaining the bells in place both the oak roof and leadwork over it was all carefully repaired.

The mediaeval curved ceiling has been re-plastered using traditional methods and materials matching that which was lost. This included taking moulds of the bosses and recasting them to exact replacements.

Internally Victorian pews and tiled floor were damaged by falling granite and these have been repaired but with a commemorative floor plaque set into the floor.

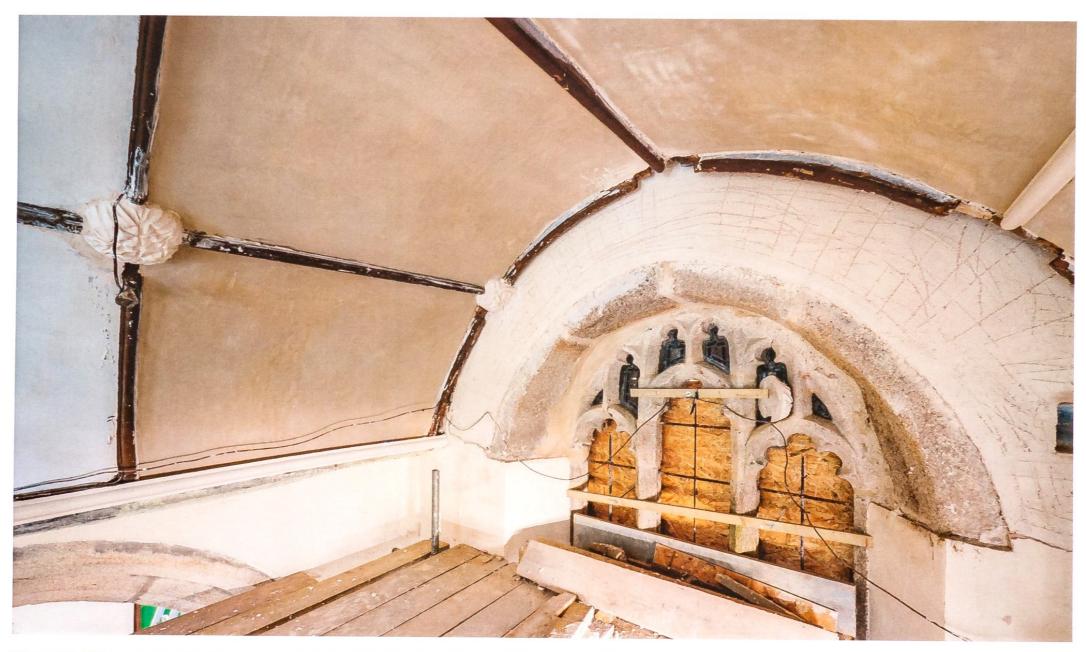
Photographs of the work nearing completion.
